TECHNICAL REPORT ARCCB-TR-99019

FATIGUE LIFE ASSESSMENT OF
155-MM M776 CANNON TUBES

NOVEMBER 1999

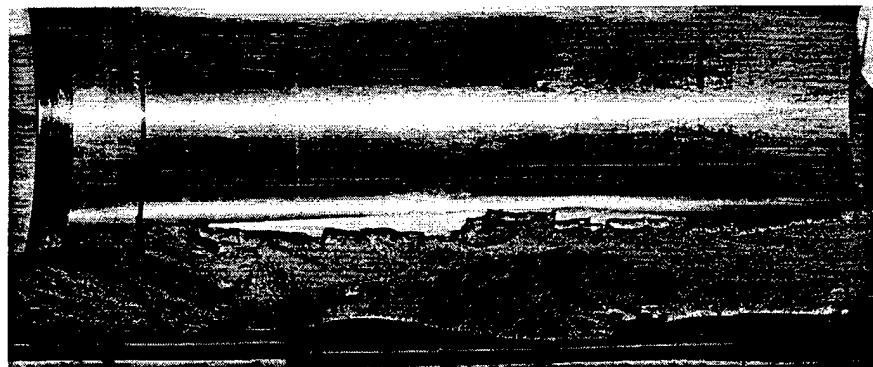
Figures 9 and 10 show failure locations of the two breech end test sections. Figures 11 and 12 show an enlarged view of the breech end test sections and the failure location. The fracture surface for each breech end test section is shown in Figures 13 and 14. Figures 15 and 16 illustrate the two keyway test sections with the failure location noted. Figures 17 and 18

It is noteworthy to mention that the -40°F Charpy impact energy and the fracture toughness values for these tubes are at the lower end of the acceptable range. These values do not correlate with any accuracy to the upper-shelf correlation of Barsom and Rolfe (ref 3), since this correlation is based on different types of steel. These low Charpy and fracture toughness values are considered to cause the unstable, running crack failure mode of tube S/N 001.

Figure 13. XM776 S/N 001 breech end fracture surface.

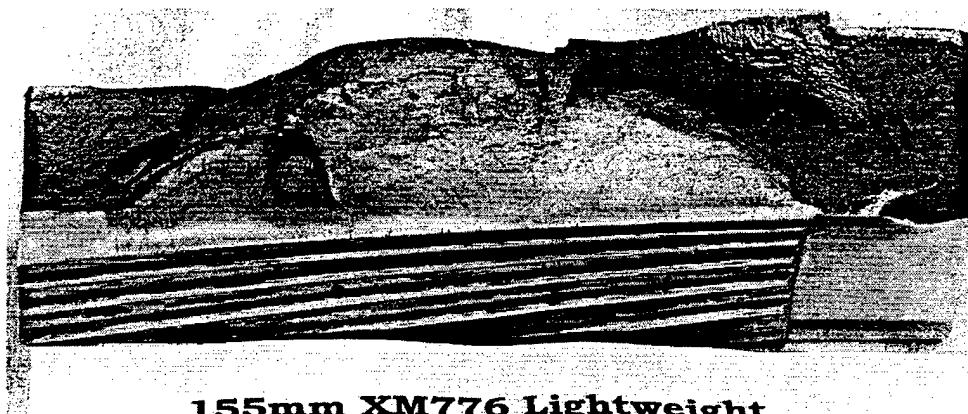
illustrate an enlarged view of the keyway test sections with the failure location noted. The fracture surface for each keyway test section is shown in Figures 19 and 20.

Figure 20. XM776 S/N 003 keyway fracture surface.
